EFFECTS OF TOTAL DOSE IONIZING RADIATION ON THE 1802 MICROPROCESSOR*

E. E. King
Naval Research Laboratory
Washington, D.C. 20375

Summary

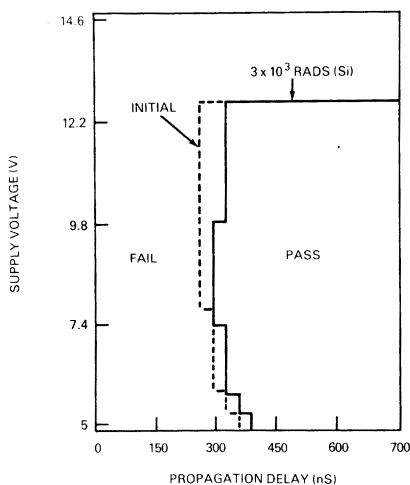
Figure 7. Shmoo plot of supply voltage versus propagation delay for address lines and functional pattern 2.

The Macrodata program which was used consisted of several functional tests with provision for printout of the power supply voltage shmooed against the propagation delay to various outputs. For example, Figure 7 shows the shmoo plot of supply voltage versus propagation delay to the address lines, MA0 through MA7, utilizing functional pattern 2 after a 3×10^3 rads(Si) irradiation. Pattern 2 included all of the instructions which increment or decrement any register (except for 1N and 2N) and all of the branch and skip instructions. The dotted line indicates the additional pass area for this device pre-irradiation. The shmoo plot obtained after the 1×10^4 rad(Si) dose point had no observable pass area. The various functional tests performed on the MD154 provided little insight into how the microprocessors failed since essentially all tests indicated complete failure at the same dose points. For this reason, only some of the propagation delay data are included in this report.

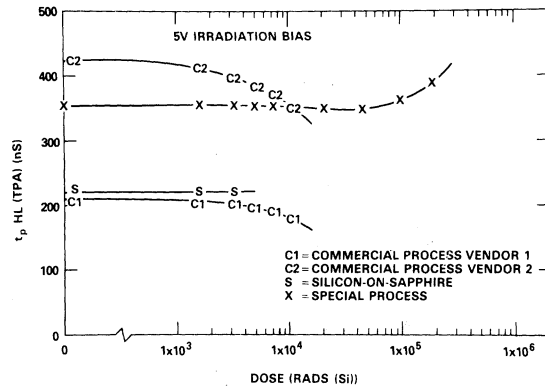
Figure 11. Example of propagation delay variations versus total dose for 1802 devices.

The propagation delay of the TPA transition from high to low, t_{pHL} , versus total dose is shown in Figure 11. Propagation delay decreases for the production and SOS devices and increases for the radiation-hardened devices reflective of the opposite variations in n-

Five other timing measurements were made routinely during the 1802 testing which were defined in Figure 6. Results very similar to those shown in Figure 11 were obtained for these other measurements; thus, the data was not included here.
